View Point Inspections

Building Inspection Report

123 Easy St.

Inspected on Fri, Jan 19 2018 at 9:12 AM

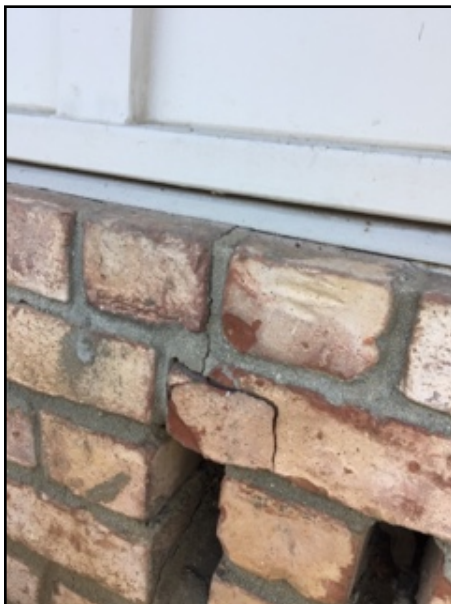
Figure 1-1

Brick veneer cracks noted. Noted at the front of home. These type of small cracks are very common due to age of home, living in a seismic area or normal home settlement. Monitor over time, we recommend cosmetic repairs as needed.

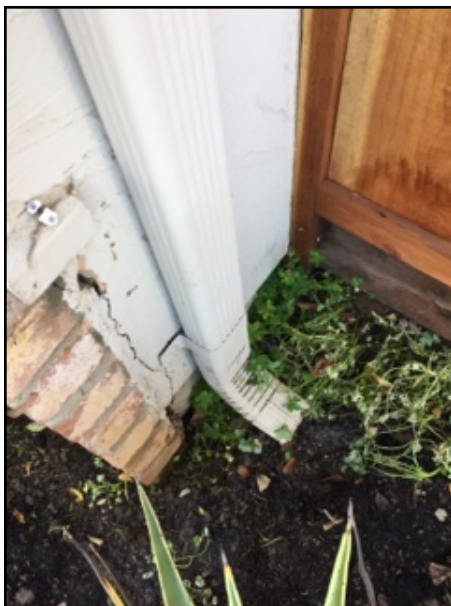
Figure 2-1

Downspouts unloading next to home's footprint. Noted at several locations around the home. Ultimately, the proper downspout extensions would be in place and they would unload at least 5 feet away from the home's footprint. Corrections are advised.

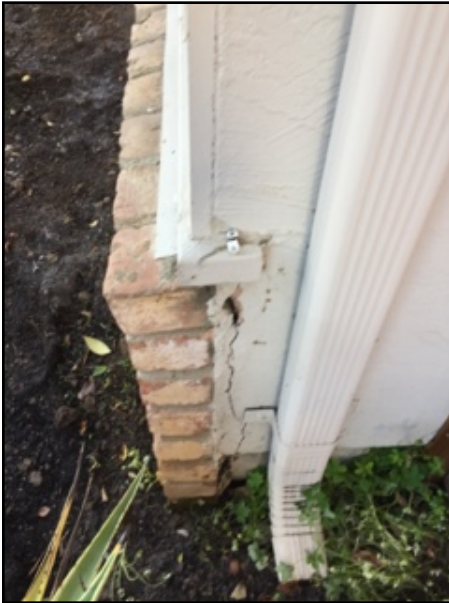
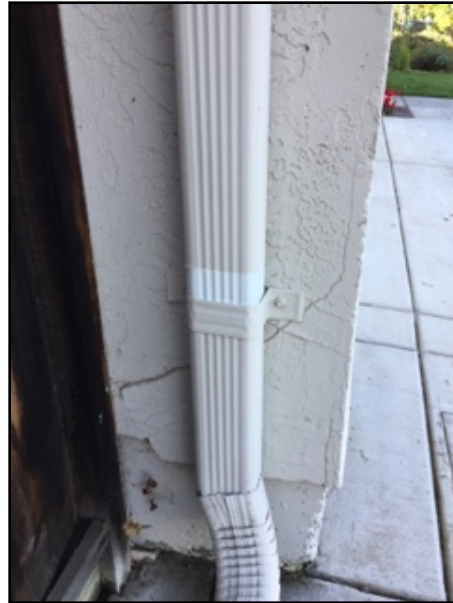
Stucco siding cracks noted. Noted at several locations around home. This is very common, due to living in a seismic area and for the age of home. We recommend caulking all cracks, then adding two coats of finish paint.

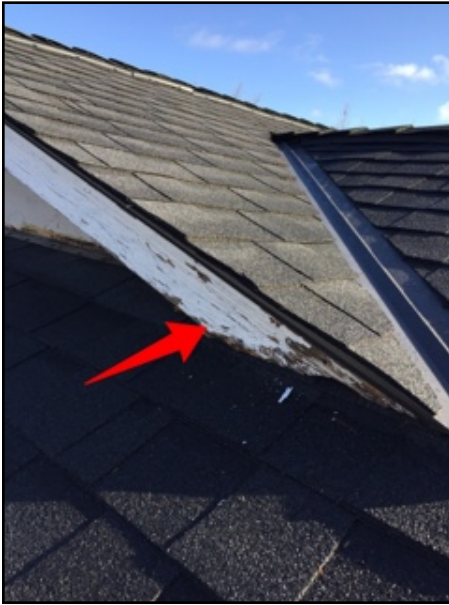
Figure 4-1

Barge rafter damage noted. Noted from the roof at the right side of home. Corrections are advised by a painting contractor.

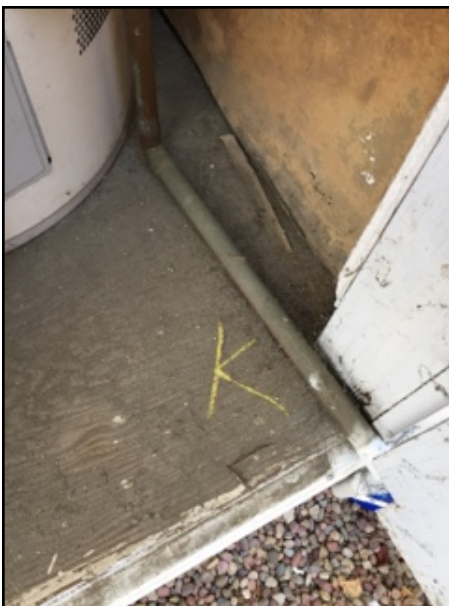
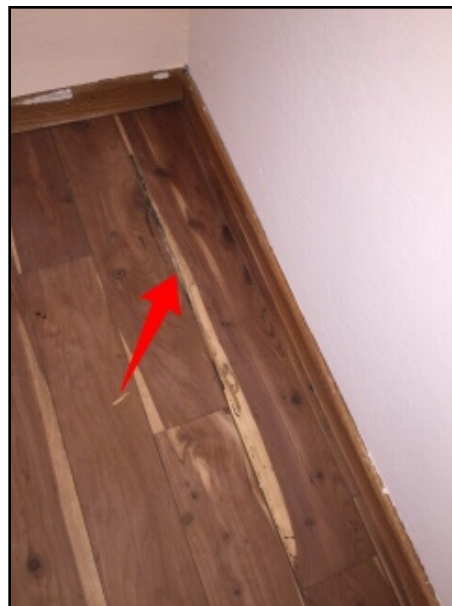
Wood boring insect droppings or evidence noted. Noted from the exterior, in the garage, at the interior, in the attic and in the sub-area. Review the most recent termite report for more information. Corrections are advised.

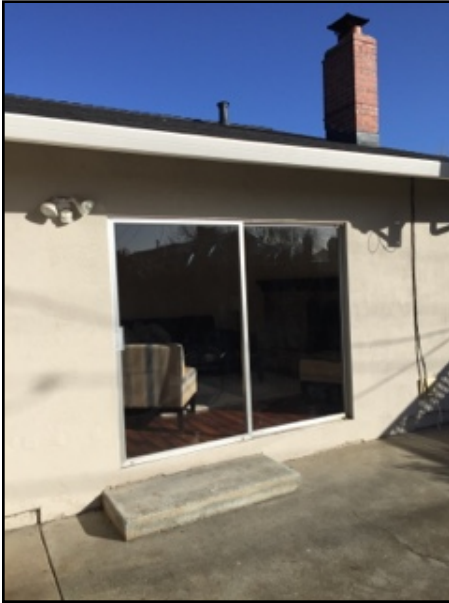
Figure 6-1

Window slider screen missing. Noted at the rear of home. Correction is advised.

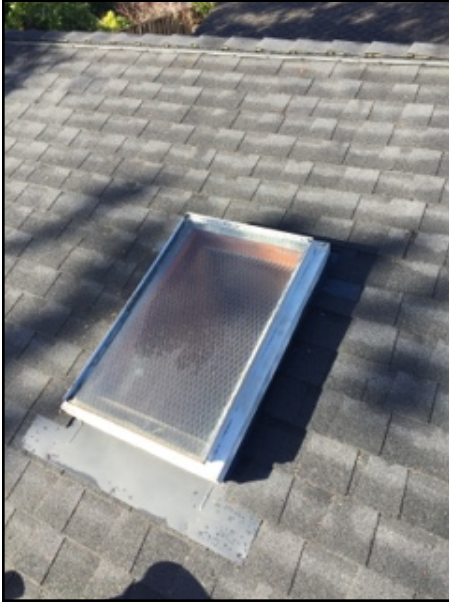
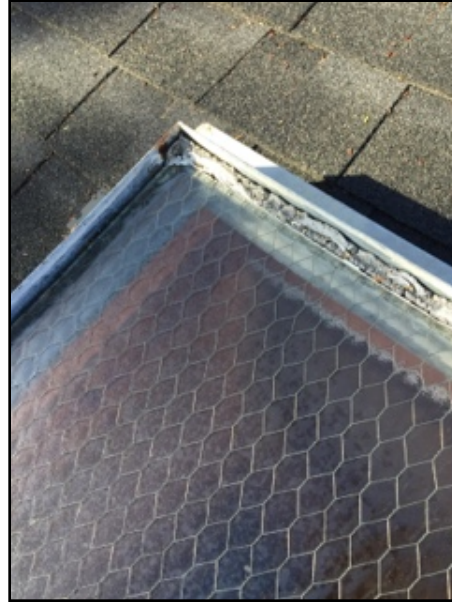
Skylight outdated. Exterior seals are in poor condition. Noted from roof. Monitor over time, correct as needed by a window contractor.

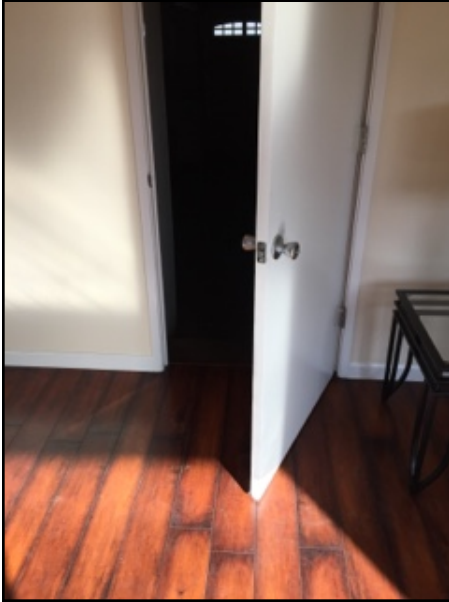
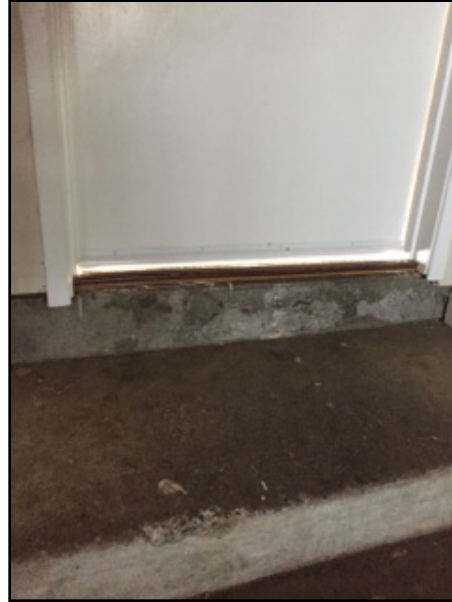
Garage door safely upgrades needed. Noted at the door that connects living space to the garage. For example: better weatherstripping/threshold is needed around entire door and adding the proper new self-closing hinge (so the door closes on its own). This current scenario is sometimes common for older homes. Caution is advised. Corrections/upgrades are advised at this time by a general contractor.

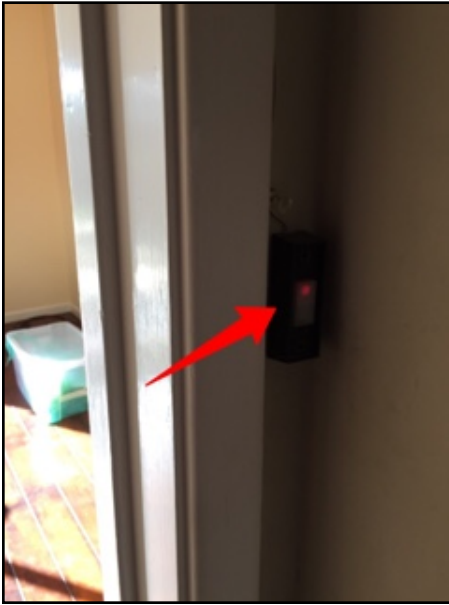
Figure 9-1

Vehicle door automatic opener wall button mounted too low. Noted at the rear garage wall. These buttons are not supposed to be mounted below 5 feet off of the near by step or garage floor for overall safety. Caution is advised. Correction is advised by a garage door contractor.

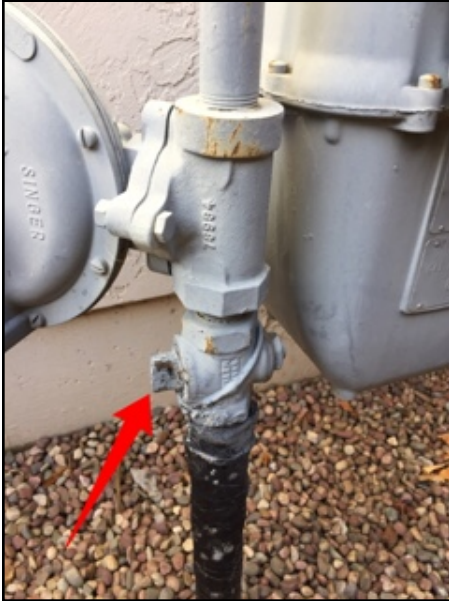
Figure 10-1

Gas main shut-off wrench not discovered. Noted at the exterior left side of the garage. We recommend adding one for overall natural gas safety, in the event of a large earthquake.

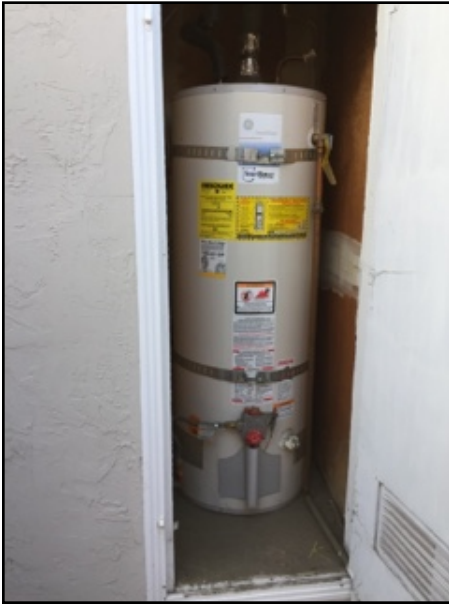
Figure 11-1

Proper water heater tank seismic restraints were noted. Noted at the exterior closet. These restraints were properly spaced and properly strapped to wall.

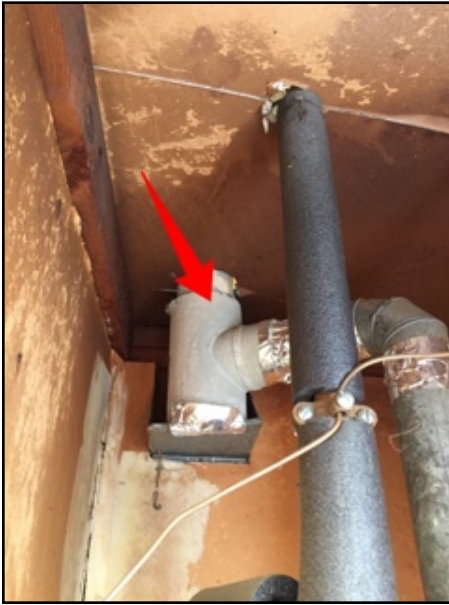
Figure 12-1

Water heater combustion vent pipe materials indifferent. Noted at the exterior closet. The exhaust fumes in these indifferent type of pipes may condensate differently, possibly creating "drip back moisture" toward the water heater tank. These old transite / asbestos vent pipes should be removed and upgraded to sheet metal pipes (original water heater install guide requires this). Corrections are advised at this time by an HVAC or plumbing contractor.

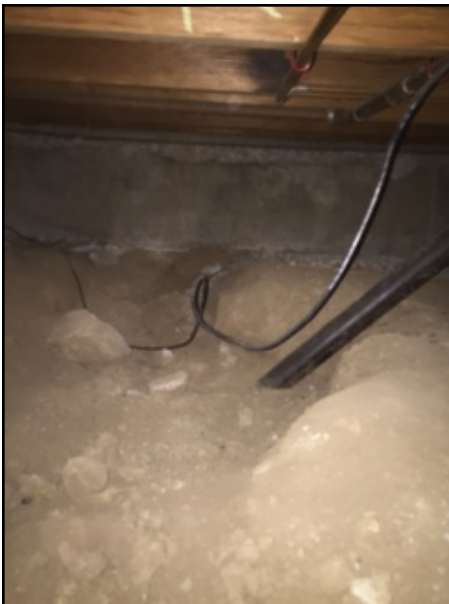
Figure 13-1

Sewer line lateral video inspection recommended. Noted from the sub-area under the mid front of home, heading to the front yard. Due to age of home and old / original cast iron piping going underground, a full video inspection is recommended at this time by a qualified licensed plumbing contractor.

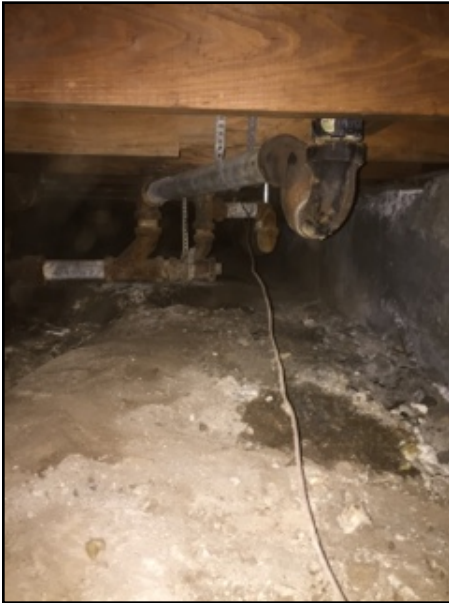
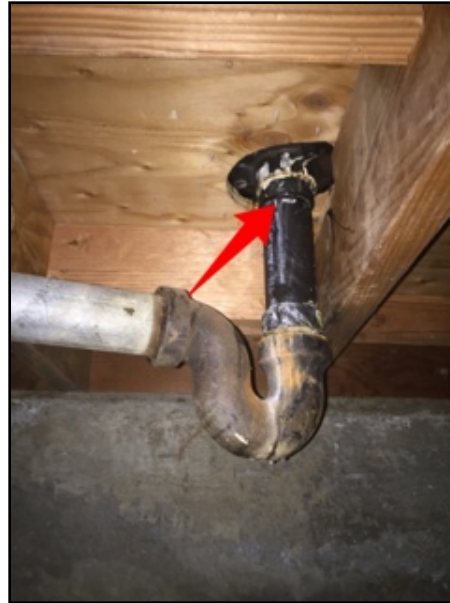
Drain trap leak noted. Noted from the sub-area under the master bathroom shower stall. A bit of moist earth was noted below. Correction is advised by a plumbing contractor.

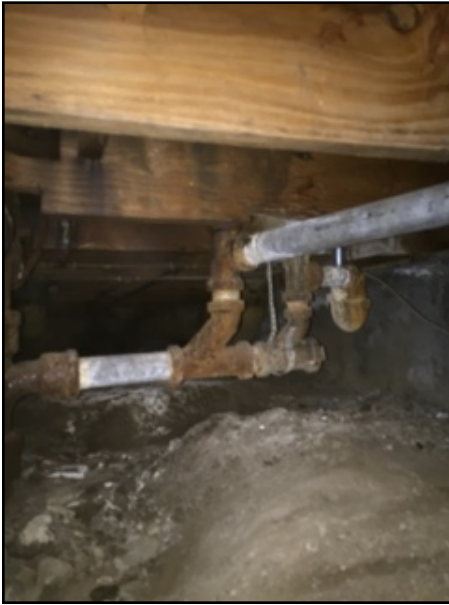
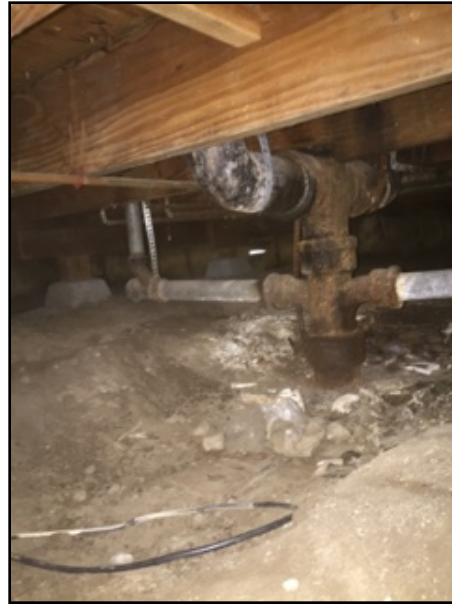
Old/original plumbing waste pipes noted. Noted from the sub-area. Areas of rust were noted. Roughly, 90% of the waste pipes were old/original. These older cast iron/galvanized pipes are very common, due to age of home, but they are beyond their life expectancy, the interior diameters of pipes may be problematic. Upgrades may be needed in the near future. Monitor the situation on a regular basis. Corrections / upgrades by a plumbing contractor, if and when necessary, are recommended.

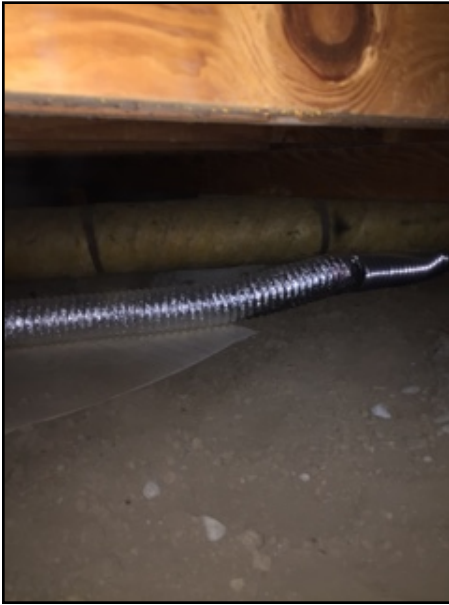
Figure 16-1

Dryer vent pipe not supported properly and on the earth. Noted in the front portion of the sub-area. Corrections are advised at this time for overall safety by an HVAC contractor.

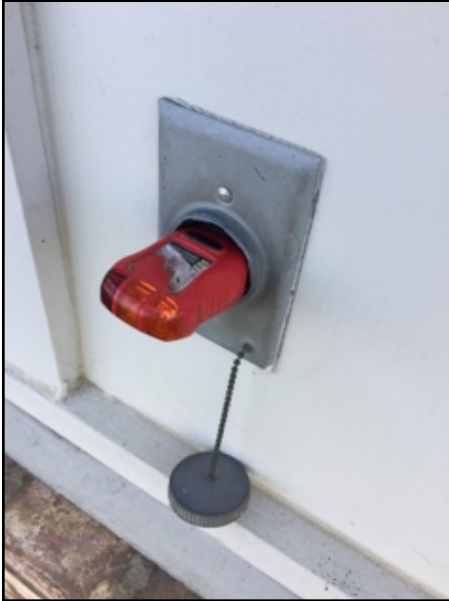
Figure 17-1

GFCI outlet upgrade recommended. Noted at two exterior outlets. This current scenario is very common, due to age of home, but upgrades are recommended for overall safety by an electrical contractor.

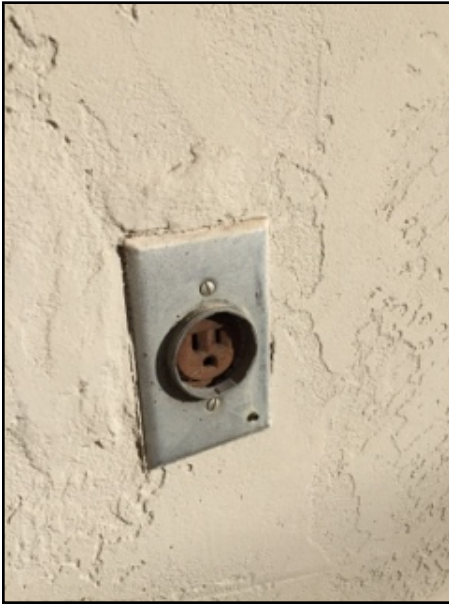
Figure 18-1

Exterior outlet weather door missing. Noted at the rear exterior of home. See comment above for more information. Caution is advised. Correction/upgrade is advised by an electrical contractor.

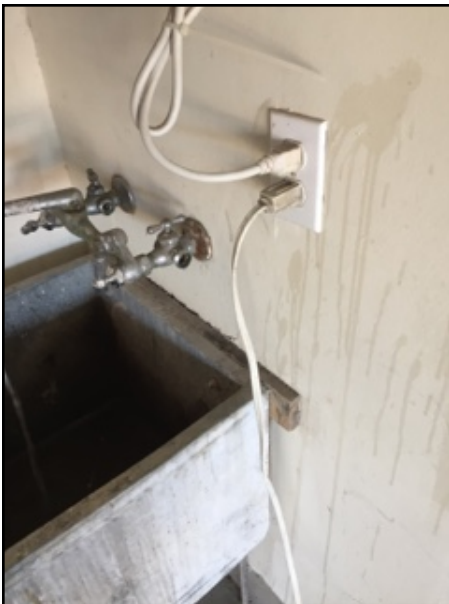
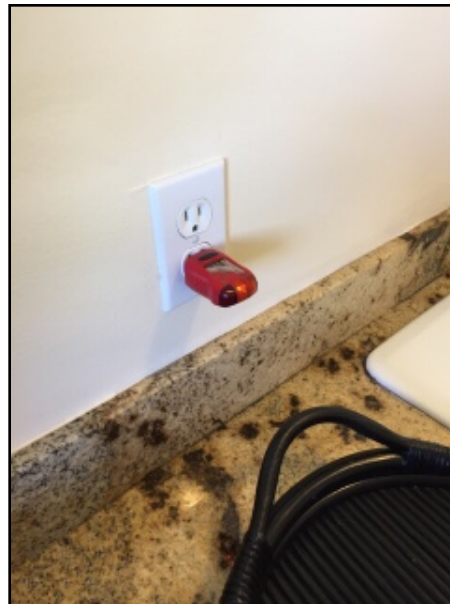
GFCI outlet upgrade recommended. Noted in the garage/laundry area and in the kitchen (outlets within 6 ft. of a wet area). This scenario is quite common for an older home. Caution is advised. Corrections/upgrades are advised at this time by an electrical contractor.

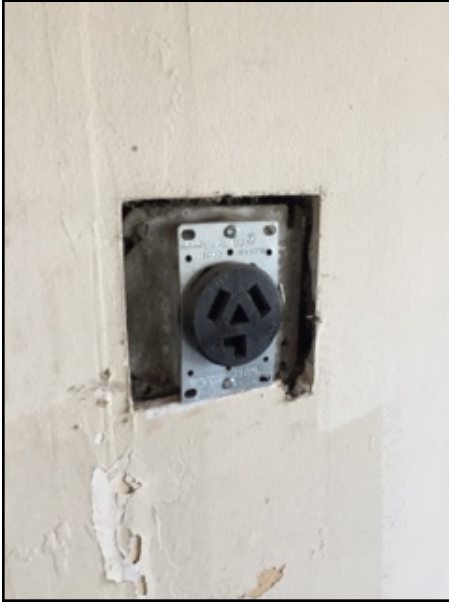
Figure 20-1

Electrical outlet face plate missing. Noted in the garage laundry area. Caution is advised. Correction is advised by an electrical contractor for overall safety.

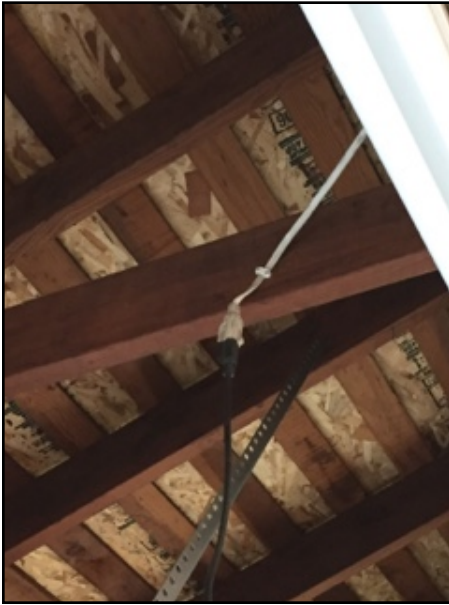
Figure 21-1

Extension cord noted at ceiling powering the vehicle door automatic opener. Noted in the garage. This is improper, extension cords are for temporary use only. Caution is advised. Correction is advised by an electrical contractor.

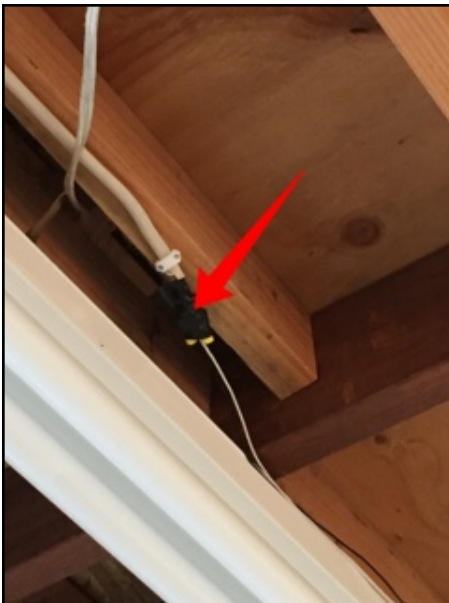
Figure 22-1

Exposed wire splice noted. Proper j box missing. Noted at the garage ceiling. Caution is advised. Corrections are advised by an electrical contractor.

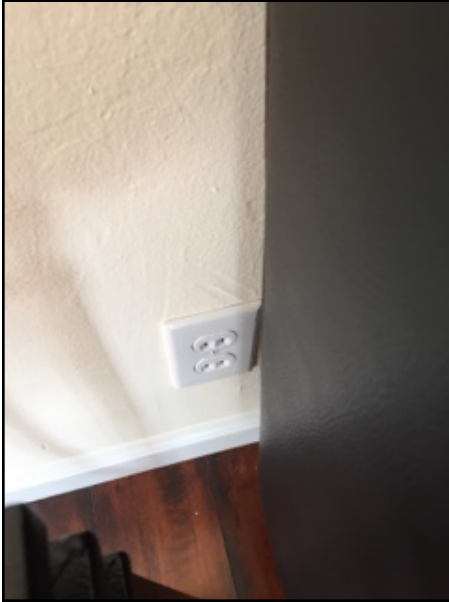
Figure 23-1

2-prong outlets noted. Noted at many locations in the home. These type of older electrical outlets are very typical, due to age of home. Due to today's electrical energy demands on a home, we recommend upgrading all of the old 2-prong outlets to properly grounded 3-pronged outlets at this time. Corrections/upgrades are recommended at this time by an electrical contractor.

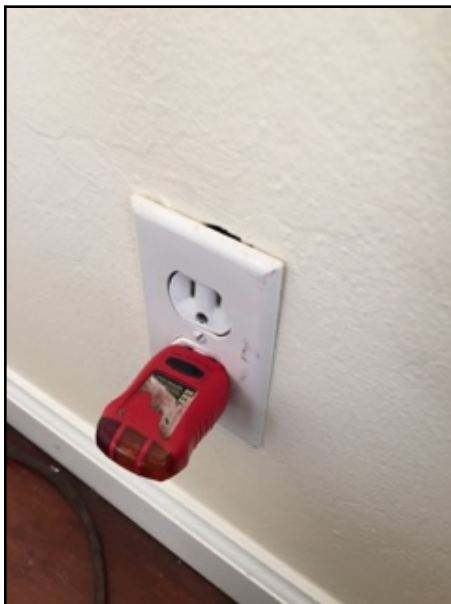
Figure 24-1

Receptacle outlet dead. Noted in the dining room. Correction is advised by an electrical contractor.

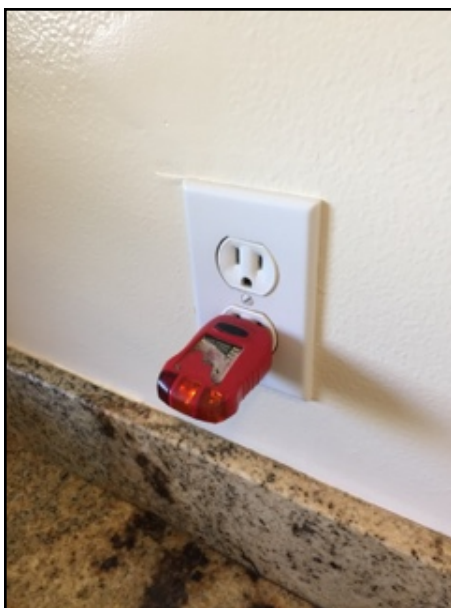
Figure 25-1

Outlets appeared to be miswired or weak signals noted. Noted at a few 3-prong electrical outlets. We recommend a full review of all 3-prong outlets in the home. Caution is advised. Corrections are advised by an electrical contractor.

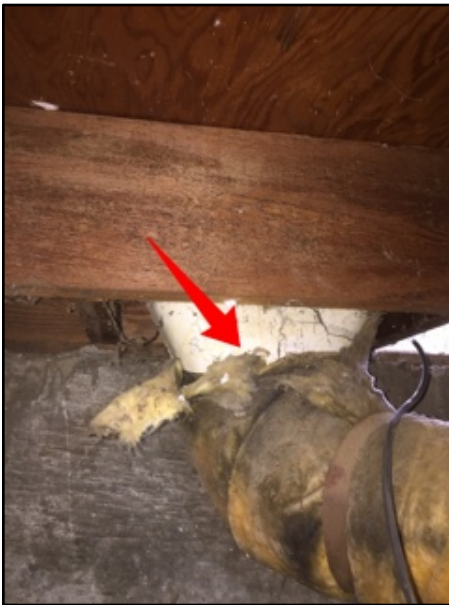
Figure 26-1

What appears to be asbestos insulative wrap noted. Noted from the sub-area at most forced air floor boots. This is very common, due to age of home, but overall we recommend removing this asbestos material and properly rewrapping the boots with fiberglass insulation. Corrections are advised by an HVAC contractor.

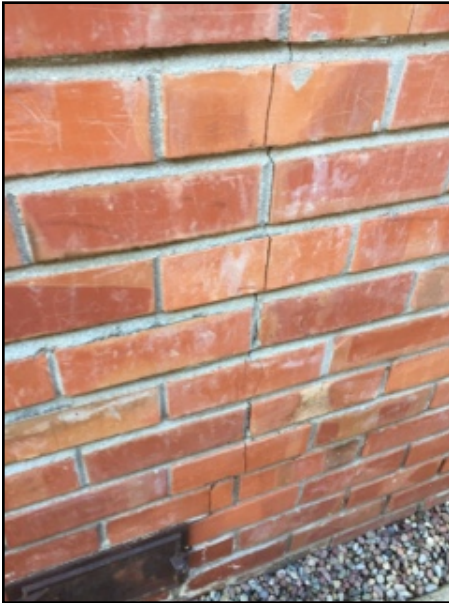
Figure 27-1

Cracks noted at the chimney. Noted from the ground. These types of cracks are very typical for age of home or living in a seismic area. Monitor over time, correct as needed by a masonry contractor.

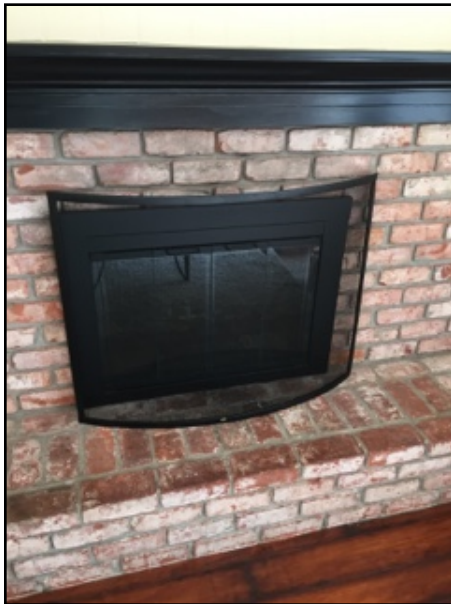
Figure 28-1

A limited fuel wood fireplace & chimney inspection was performed. Noted in the living room & the adjacent roof. Normal usage/damage was noted in the fire chamber. The full inspection of this type of fireplace flue is very difficult. We recommend a full fireplace cleaning and a NFPA Level 2 inspection by a qualified fireplace contractor. Go to: www.csia.org for more information

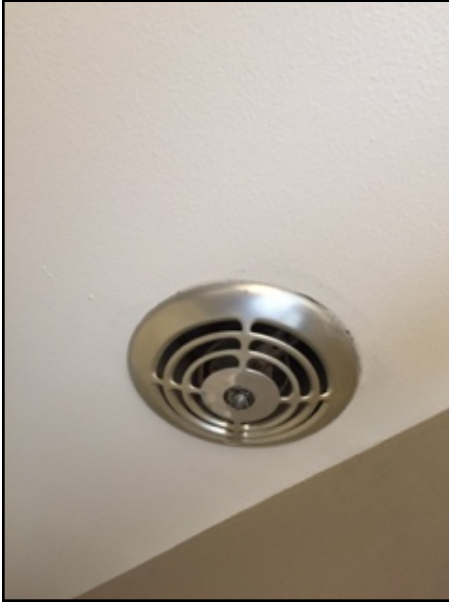
Figure 29-1

Exhaust fan noisy. Noted in the hallway bathroom. Correction is advised by an HVAC contractor.

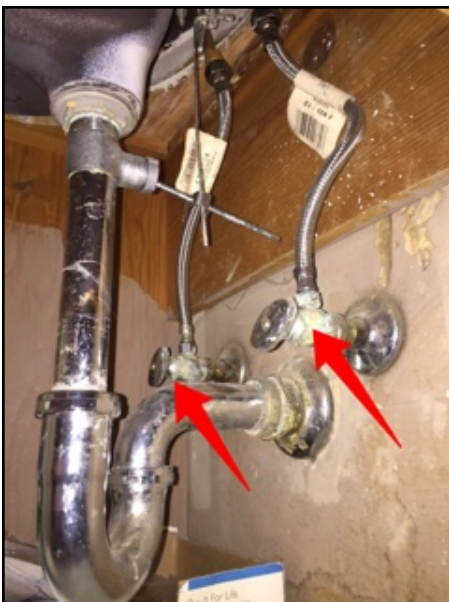
Figure 30-1

Water supply pipe valve corrosion noted. Noted under the hallway bathroom sink. Monitor this area closely for leaks. Correct as needed by a plumbing contractor.

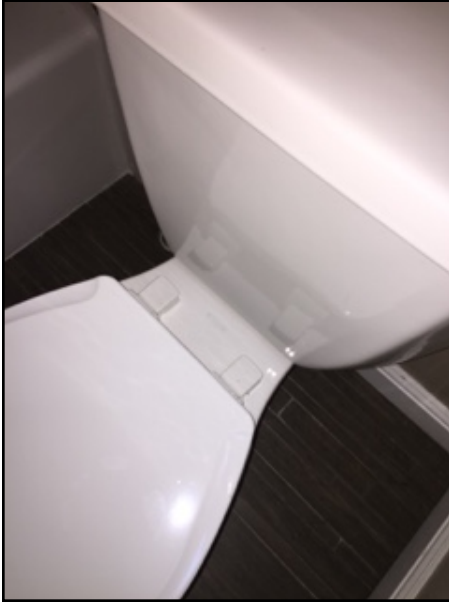
Figure 31-1

Low-flow toilets noted. Noted at all bathrooms. The toilets do comply with the local water district's current standards.

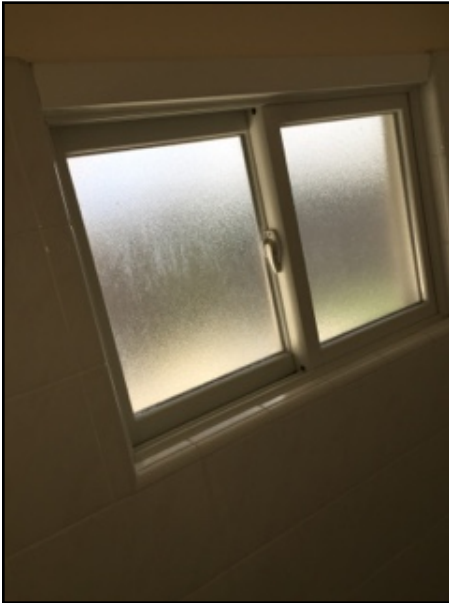
Figure 32-1

Window sill seams below showerhead needs better sealing. Noted at the master bathroom. Small grout cracks were noted at the window sill. We recommend sealing these cracks with clear silicone tub caulking. Correction is advised.

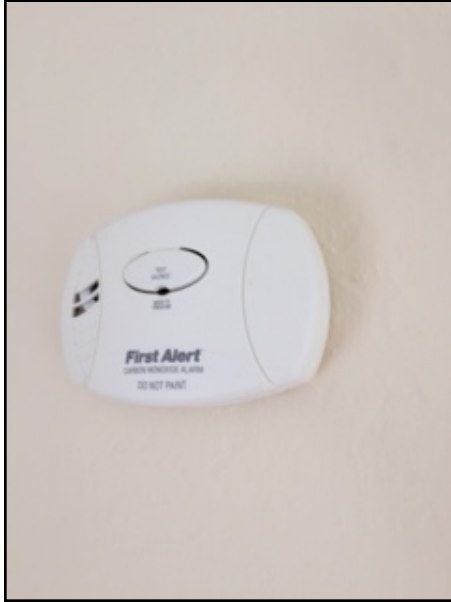
Figure 34-1

Proper / functioning carbon monoxide alarms noted. Noted at the proper locations (one per floor and/or within 10 ft. of all bedrooms).

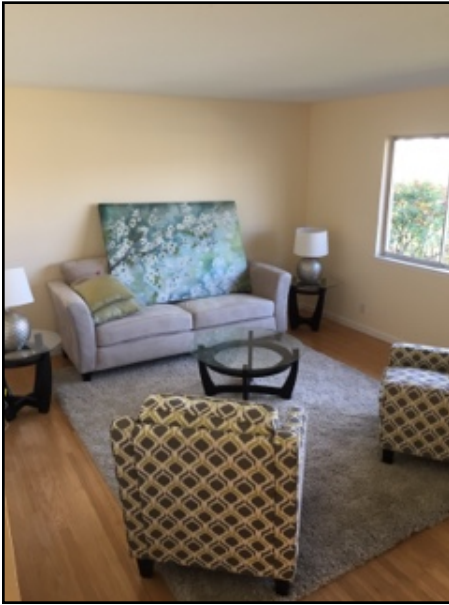
Figure 36-1

Access impaired. Noted throughout the interior. Personal items blocked full visual access to all interior areas of home. We recommend further study once the personal items are moved.

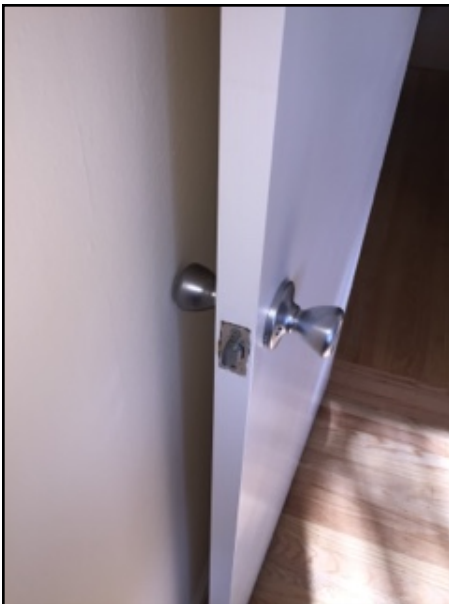
Figure 37-1

Door stop needed. Noted at the master bedroom. Correction is advised.

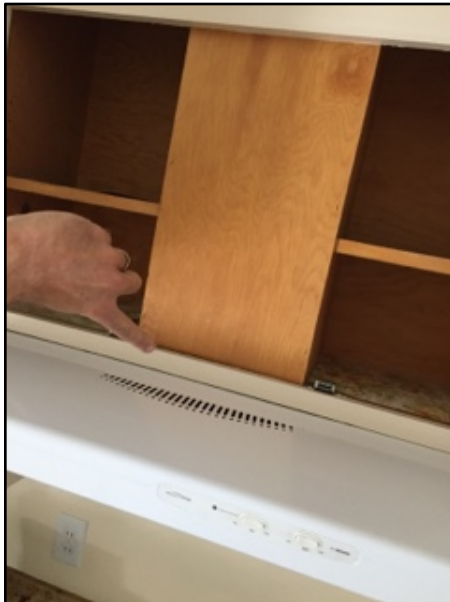
Figure 39-1

Exhaust fan system improperly installed. Noted in the kitchen. Currently the exhausted air dumps back into the kitchen, rather than atop the roof. A mechanical vent pipe was noted and in place, but just not in use. Correction / upgrade is advised by an HVAC contractor.

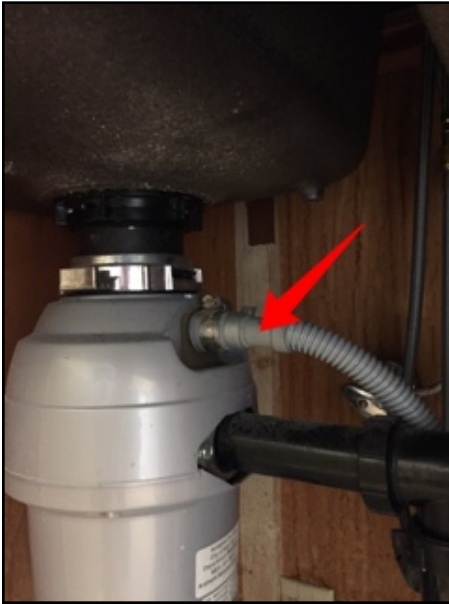
Figure 40-1

Dishwasher air gap not discovered atop counter. Noted in the kitchen. The primary dishwasher drain line went directly to the disposal. We highly recommend that the dishwasher have the proper air gap in place. We recommend correction by a plumbing contractor for overall drain efficiency.

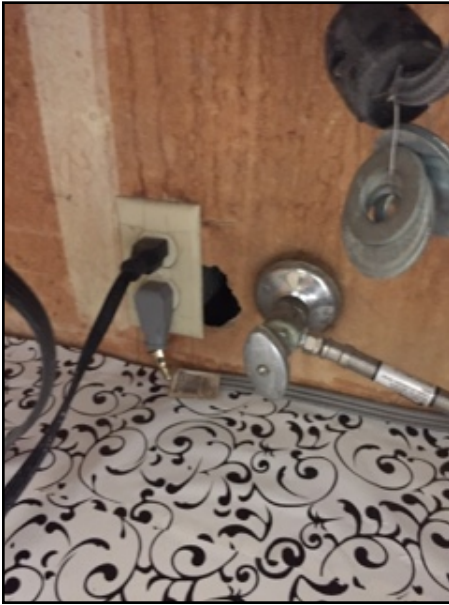
Figure 41-1

Wall holed. Noted under the kitchen sink (potential rodent entry). We recommend repair at this time.

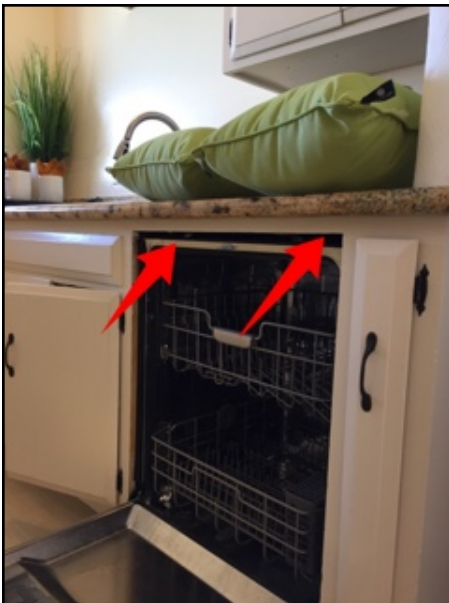
Figure 42-1

Dishwasher loose in place. Mounting brackets may be faulty. Noted in the kitchen. The dishwasher was not tested. Correction is advised. Further study is advised.

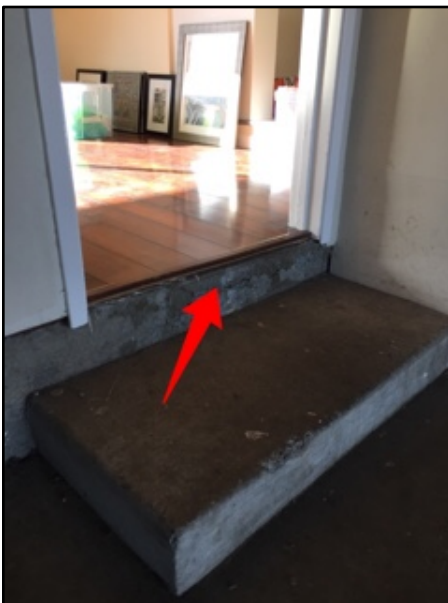
Figure 43-1

Slab foundation crack noted. Noted in the garage. These type of cracks are very typical for the age of home and for living in a seismic area. Monitor over time, correct as needed by a general contractor.

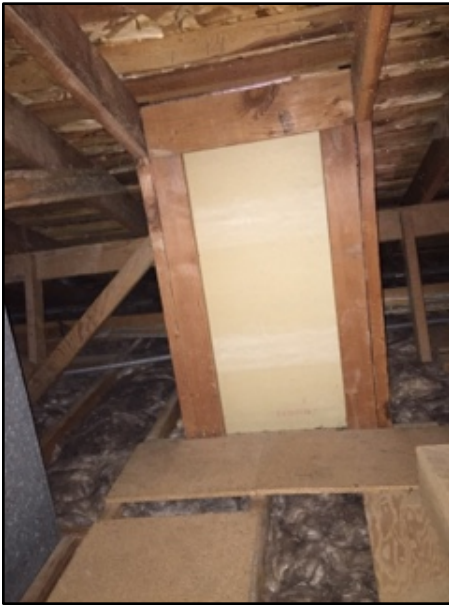
Figure 44-1

Skylight well not properly insulated. Noted from the attic hatch. Correction is advised by an insulation contractor.

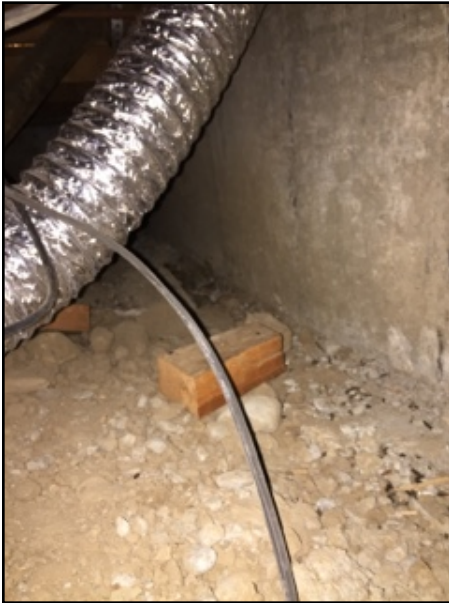
Figure 45-1

**Comment 45:**
Cellulose debris noted. Noted from the sub-area at several locations. We recommend clearing out all wood chunks or cardboard pieces to avoid subterranean termite infestation.
